# Work Log of Apple Power Mac G5 Quad Liquid Cooling System Pump Repair

While repairing the LCS unit of a G5 Quad, the original pump got damaged and stuck at the highest speed. It appeared to be doing its job just fine, but it was a little noisy and possibly shorter lived (or making the rest of the system shorter lived) than when under proper speed control. So, the pump was replaced.

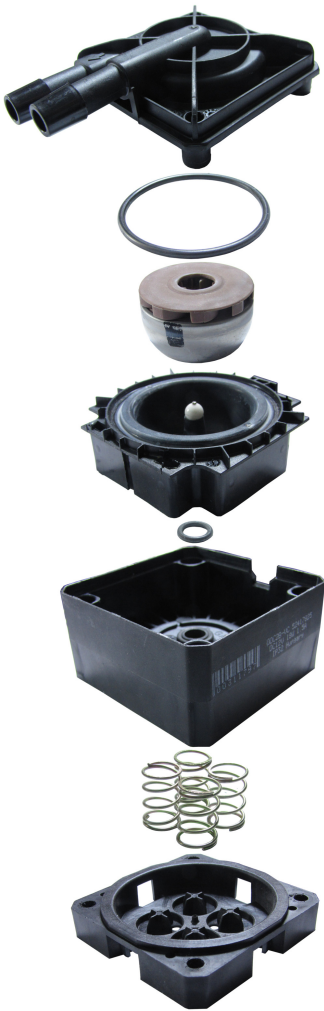
There are two Torx T15 screws that hold the pump on the LCS base plate. These screws were first removed by loosening each a few rounds in turn. Then the detached pump was taken apart by removing the four Torx T15 screws that hold it together, again, by loosening each one a few rounds in turn. The volume compensator is spring loaded and jumps in one's face like a jack-in-the-box.

After removing the screws, as mentioned, the bottom of the pump, along with the springs, jumps right off. The pump top and the top O-ring also detach easily. Being held by strong magnets, lifting out the impeller requires slight force. The bowl part that also holds the PCB is held in the volume compensator by the smaller O-ring and possibly by some small dots of adhesive. The bowl part was carefully pryed out using a spudger or something like that.

*DDC2B-VC blowout*

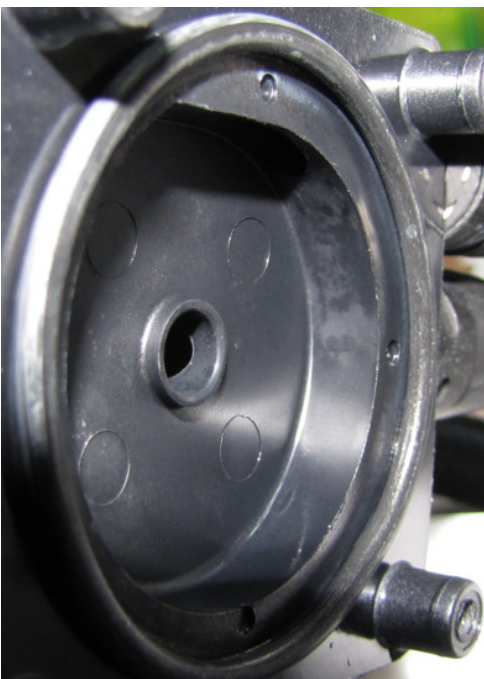
Removing the PCBs was an exercise in futility for several reasons. First and foremost, the motor housing parts are not the same mold between the DDC-2 and DDC-3 models, and the PCBs cannot be exchanged without some Dremel work. On the other hand the DDC-3 motor housing lacks the little overflow hole found in the DDC-2 housing to utilize the volume compensator. The impellers are also of slightly different size. Finally, the DDC-2 pump top cannot accommodate the DDC-3 impeller, because the DDC-3 impeller has a smaller inlet and the DDC-2 top has a protruding ring around the inlet, which would contact the DDC-3 impeller.

*DDC-2 pump top, ring around the inlet*

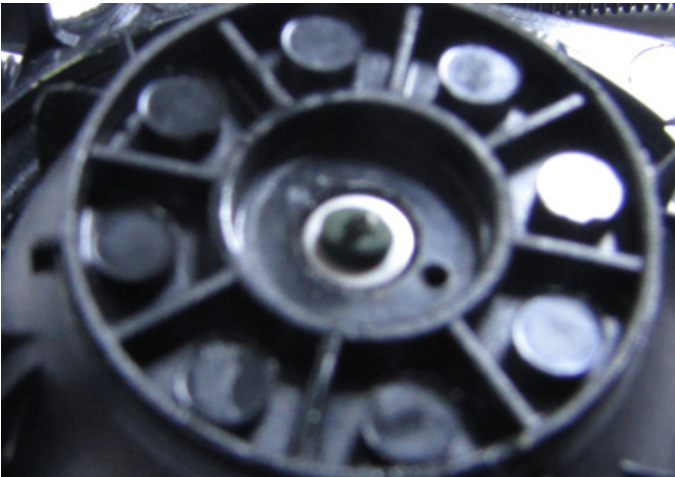
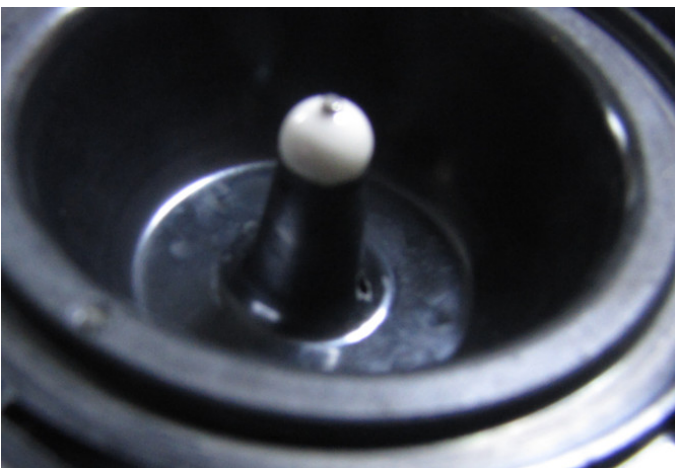
*DDC-3 motor housing modded for the VC, bottom*

*DDC-3 motor housing modded for the VC, bowl*

Bearing in mind that the DDC-2 has a small hole for the liquid to pass to the volume compensator, the DDC-3 motor housing had to be modded to the same effect. A Dremel type tool and a 1.5 mm drill bit was used to drill a small hole through the bottom of the housing to the bottom of the bowl side. Over 10k rpm was needed for the drill to start eating into the hard plastic.
