# Work Log of Apple Power Mac G5 Quad Liquid Cooling System Repair

This text represents a work log of a cooling system repair done to a Power Mac G5 Quad (version 1 LCS with a single pump). I have also gathered links and related information to go with it as finding out the necessary bits was rather daunting; it is easier to have all the information in one place. The text, naturally, is written on the repaired Quad.

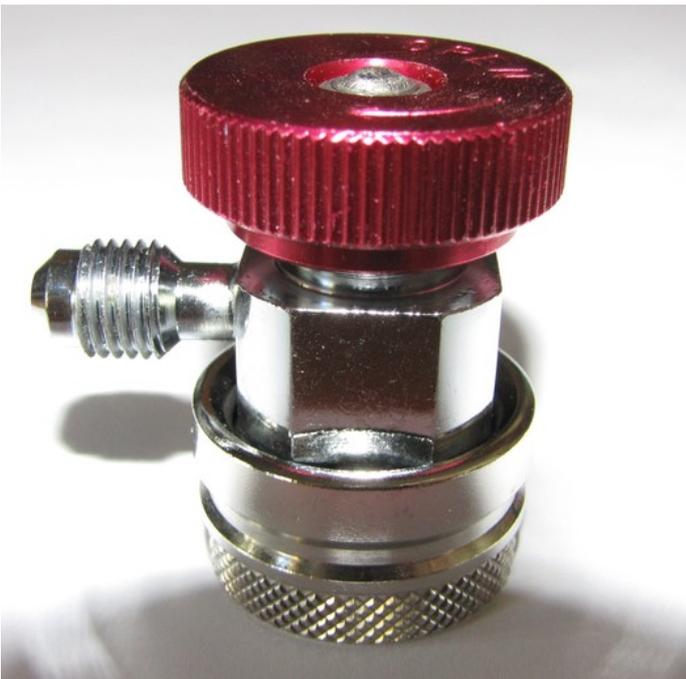
The r134a service port is an air conditioning service port. Port couplers can be found from A/C service equipment suppliers, and the couplers are rather expensive, but in my opinion a worthy buy for the project. Hoses and fittings are available from hydraulics stores. Alligator clips can be found from hobbyist electronics stores. Springs clamps, hose removal pliers, and fuel pump gauges are sold by automotive parts stores. Aspirator pumps are available at laboratory equipment suppliers.

*R134a service port coupler*

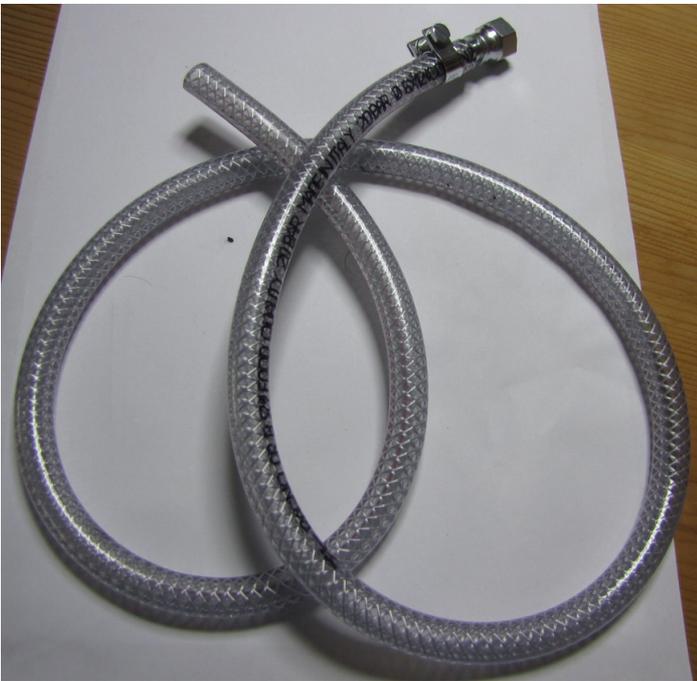
*The service hose*

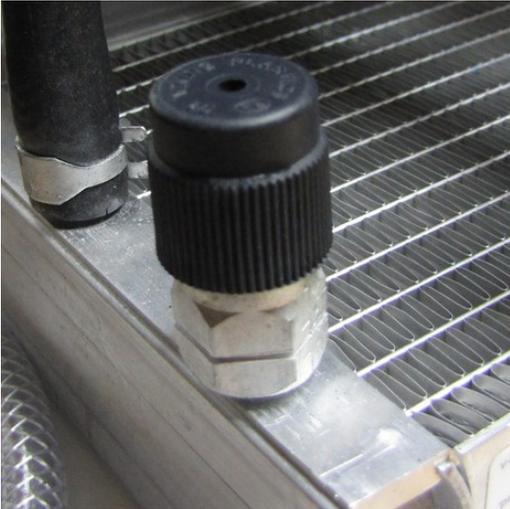
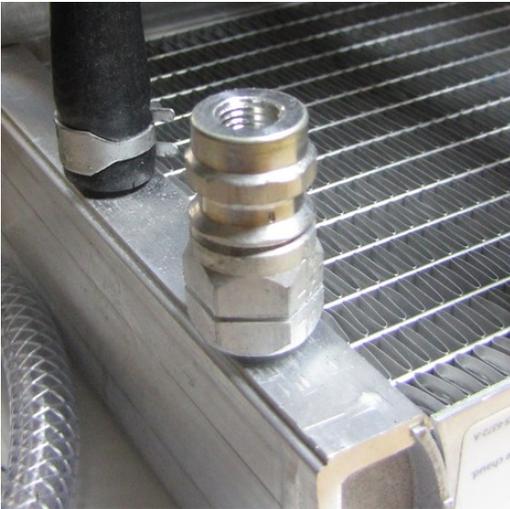
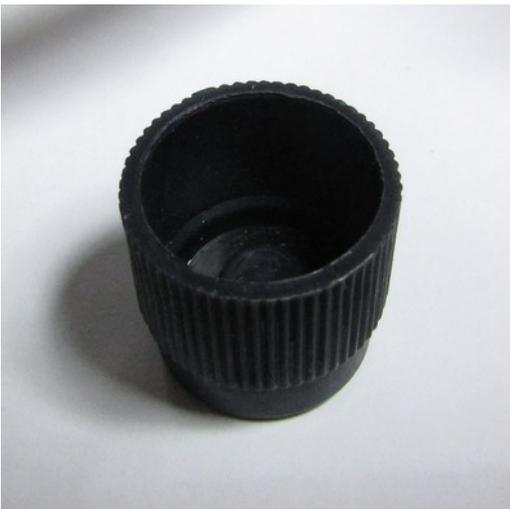
The LCS has a R134a high side service port (the one with the black cap). The cap screws off the port easily. Removal of the valved port itself is less obvious as the hex nut at the base of the port is welded to the radiator. The port can be removed by holding the hex nut steady with a wrench while gripping the top part (which was covered by the cap) of the port with pliers and screwing it out.

*R134a port with cap on*

*R134a port with cap removed*

*R134a port cap*

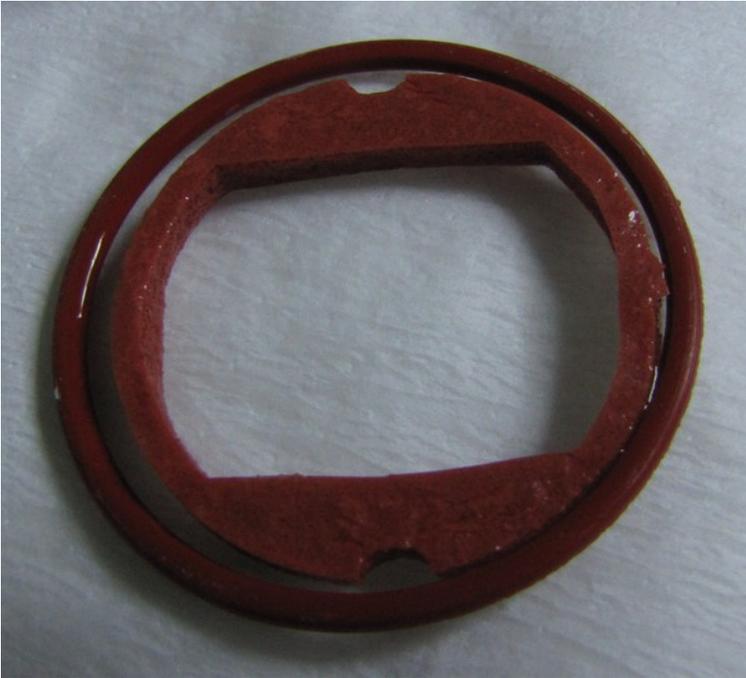
*CPU block O-ring and red foamy pad*

The CPU blocks were rebuilt by seating the red O-ring, the red foamy pad, and the white plastic maze in the plastic CPU block top of each CPU block. The red foamy pads were slightly deformed from the outlet side, so they were turned 180° compared to the original position. The copper CPU block bases were then reinstalled by gradually tightening the four mounting screws in a circular pattern. There might be a designed, "correct" way to tighten the blocks so that the O-rings would be least likely to go out of place, but that of course isn't known.

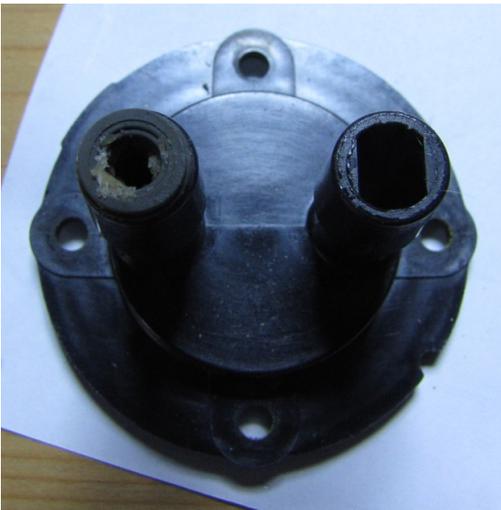
*CPU block top showing some residue*

The copper CPU block bases were cleaned up by soaking in white vinegar for a while (maybe 30 min) and then brushing with a toothbrush. Plastic, silicone, and rubber parts were cleaned up by soaking in hot water spiked with a drop of dishwashing soap. Cleaning of all parts was finished by rinsing in distilled water.

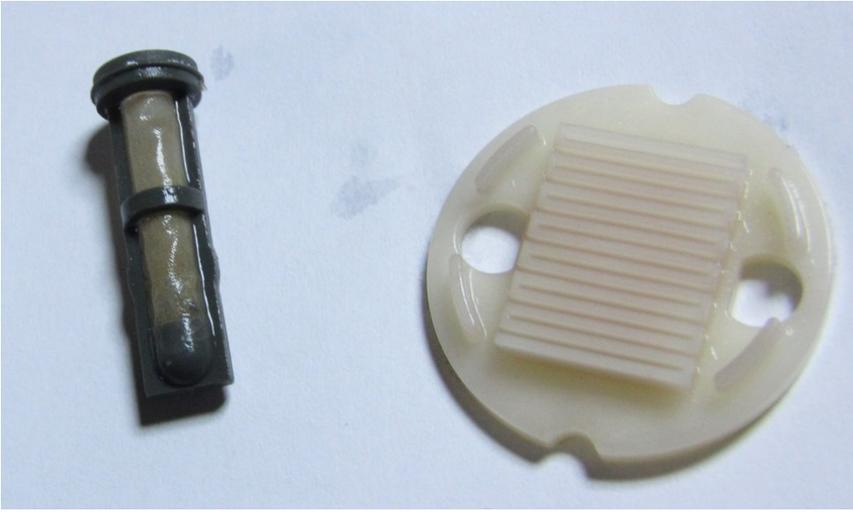
The inlets of the CPU blocks, with hoses coming from the radiator, contain a small screen filter, an AC orifice tube filter, actually. Care should be taken when removing the hoses to not damage the filters.

*Screen filter and white maze of a CPU block*

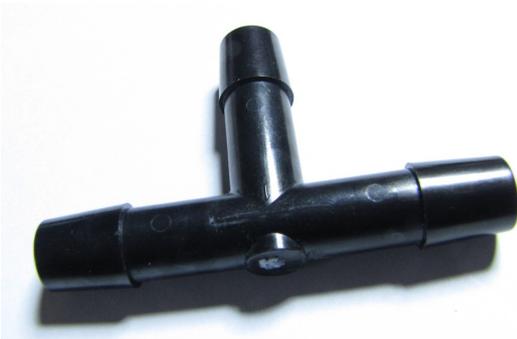
*The T-fitting*

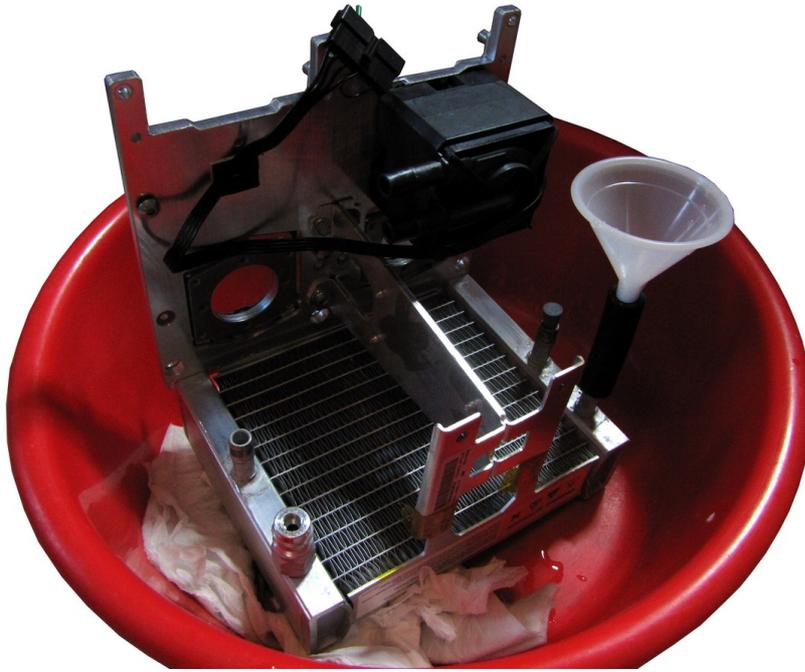
*Setup for radiator cleaning with vinegar*

1. Boil cold tap water.
2. Mix a 30:70 to 50:50 of white vinegar and hot water.
3. Pour the mix in the radiator.
4. Let sit until cool to the touch. Shake and pour the liquid out.
5. Inspect the liquid against a bright light for debris.
6. Go to step 1 until no apparent debris visible.
7. Connect the pump to the radiator and run a few liters of water through it with all routing combinations.
8. Rinse a few times with distilled water and inspect the water coming out for debris. If still not clean, back to step 1.

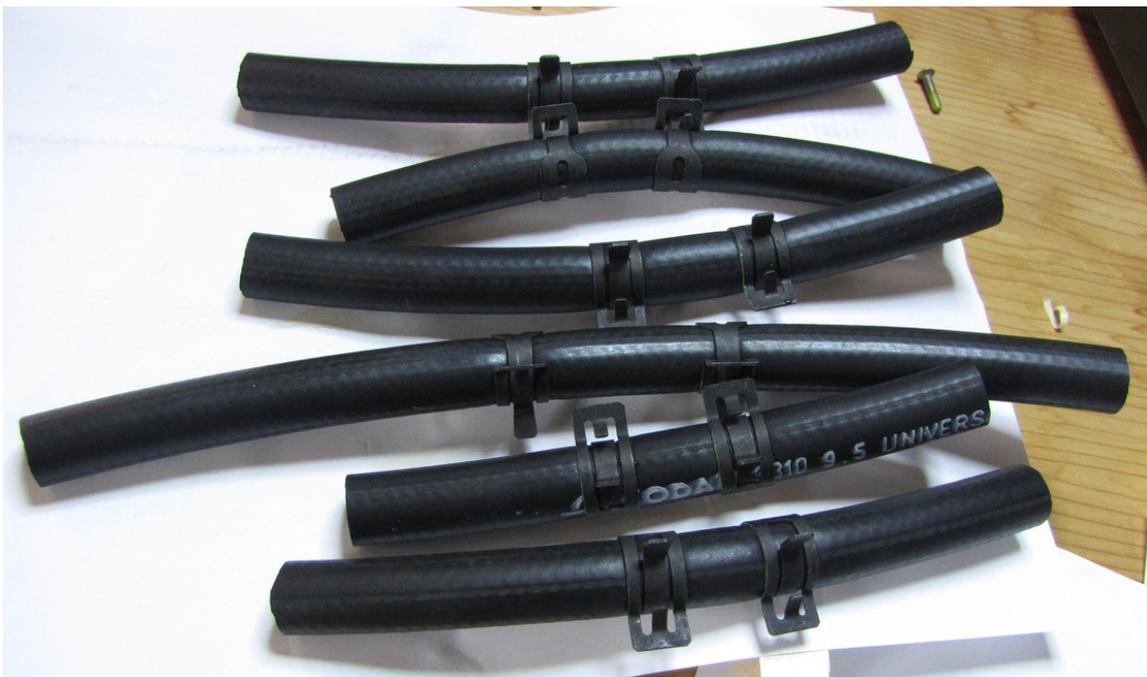
*Hoses cut and clamped ready for install*

The hoses were first cut to length by wrapping a straight piece of paper around the cut point and gripping the point with pliers that have a straight side edge. Then a carpet knife was used to cut the hose, pressing the knife towards the pliers to get a straight, clean cut.

After cutting, the pieces of hose were cleaned with the aforementioned cleaning method and then clamps were inserted mid-hose.

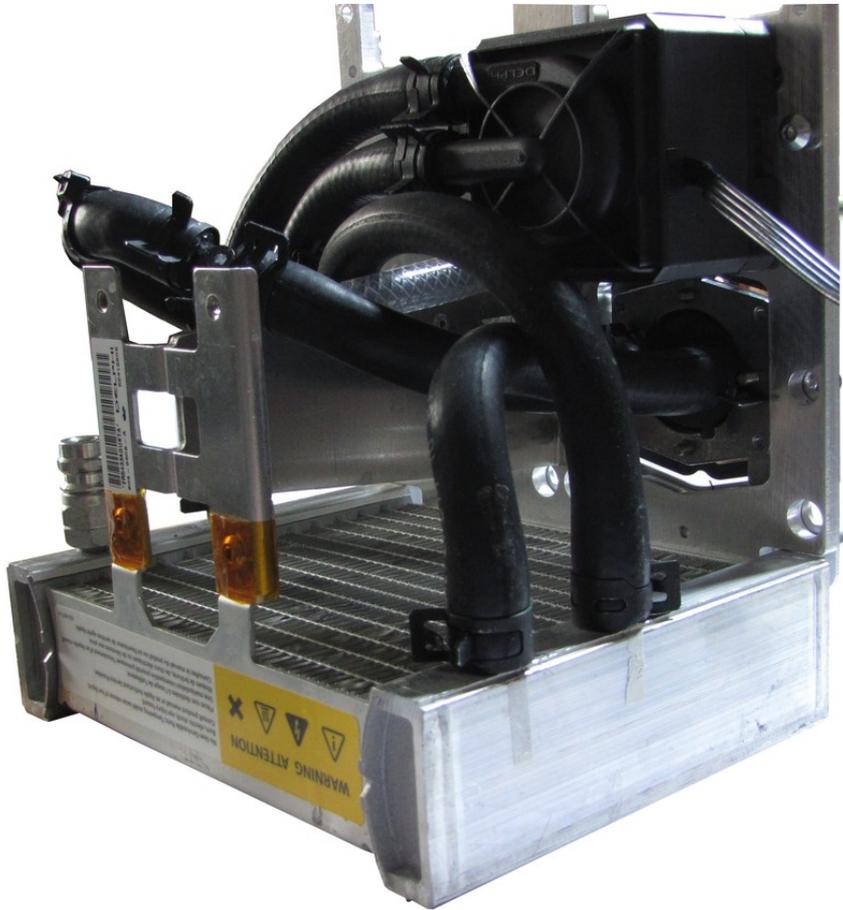
*Rebuilt LCS*

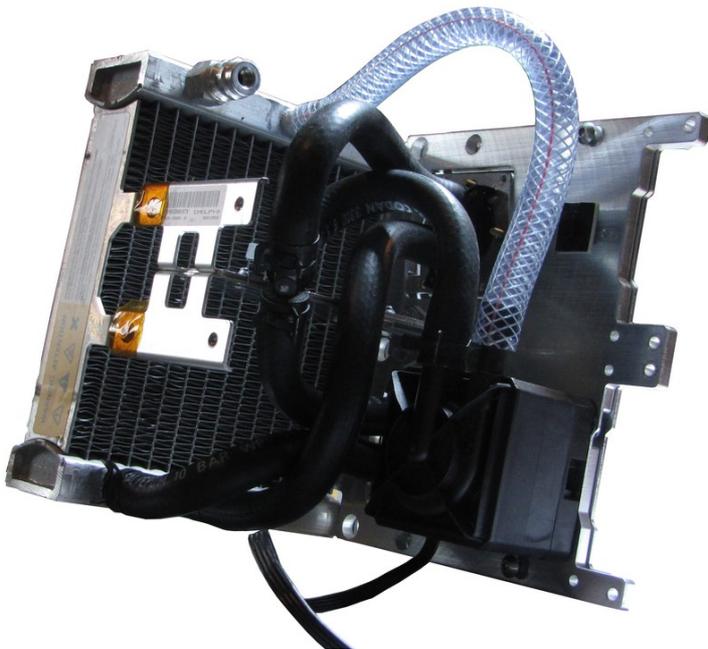
Initial refill testing was made with a translucent hose connecting the pump to the radiator. This setting allowed assessing the amount of air in the system. With the refill method perfected, the translucent hose was later replaced with EPDM hose.

*Initial refill setup with a clear hose*

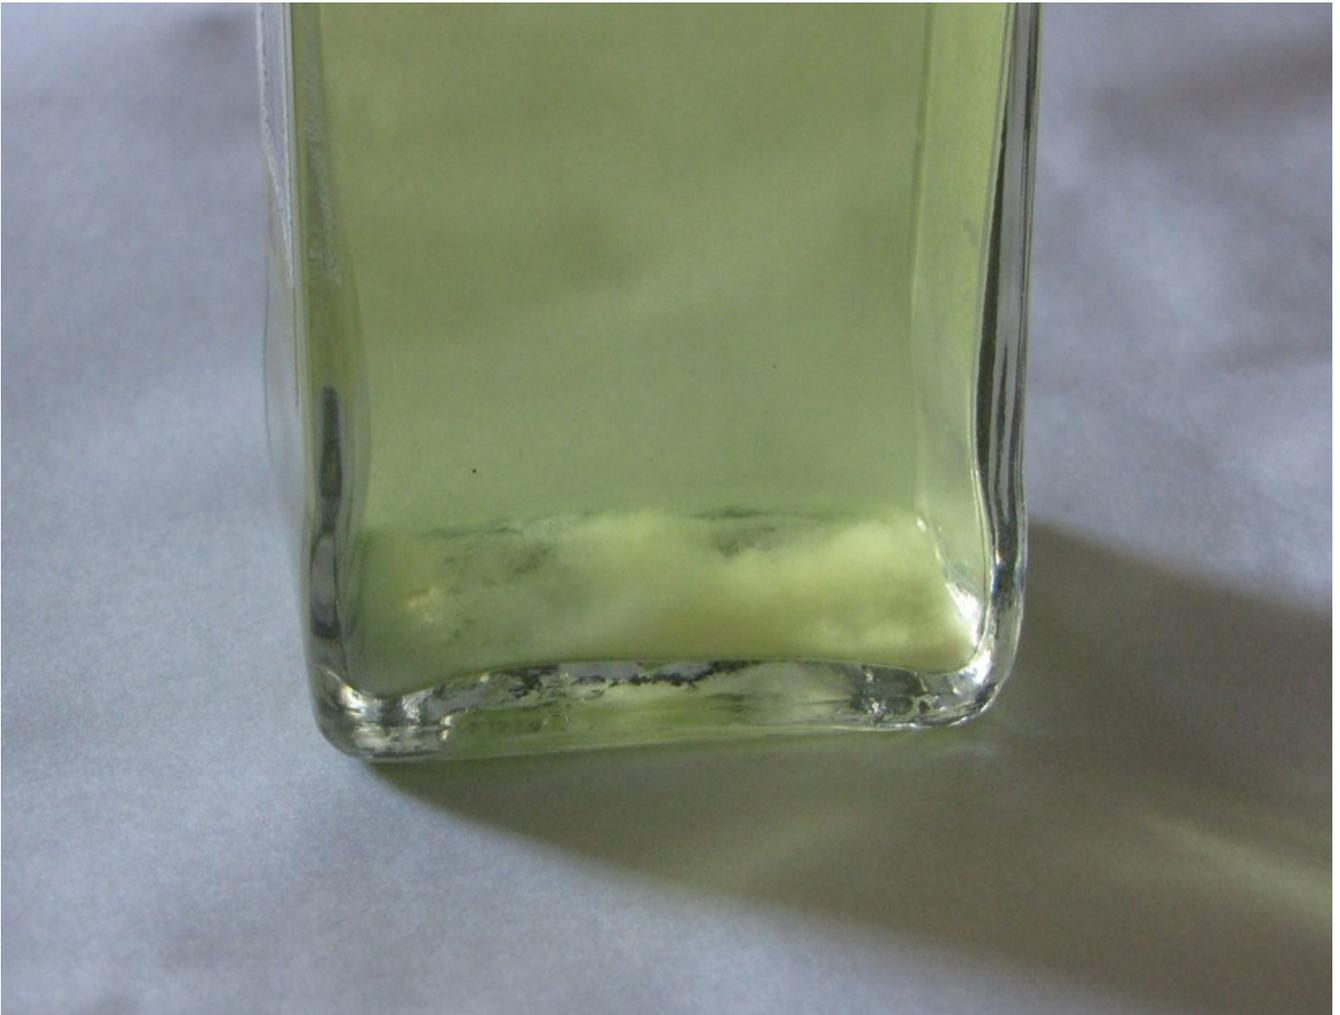
The original coolant is light green "Delphi A2 Cooling Fluid" with a fairly strong odour. It seems to "sediment" rather heavily. The coolant is mainly composed of propylene glycol and distilled water. Contrary to what is claimed around various web forums, it is not very toxic. The previous Dual G5 systems had coolant that is a different story.

*Delphi A2 fluid sedimentation*

Clear version of Thermochill EC6 was selected as the coolant as it has the necessary corrosion inhibition, even proven to automotive standards, it is non-toxic, and it doesn't contain any dyes. Dyes can break up and smudge or clog a cooling system. Other suggestions for corrosion inhibiting cooling fluid (after already selecting the EC6) encountered were the Sierra coolant and Glysantin G48, both automotive coolants. Apparently, a mix of 1/3 of Sierra propylene glycol antifreeze and 2/3 of distilled water was used in similar systems.

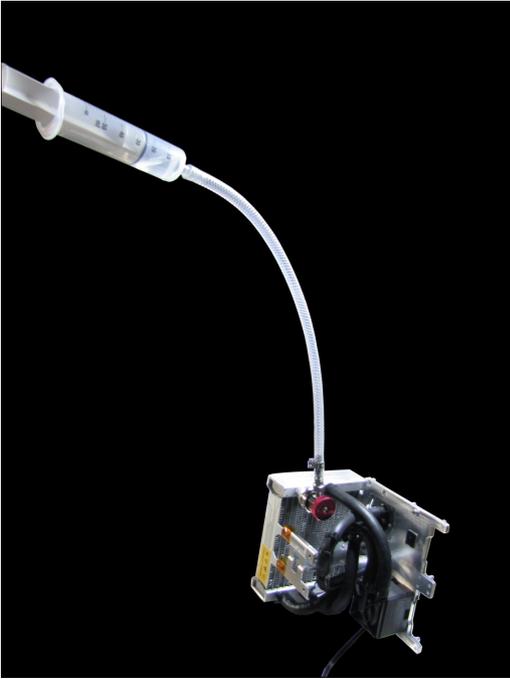
*Syringe attached to the LCS for bleeding*

About 20 ml of coolant was first pulled in the syringe and the syringe then connected to the hose connecting to the service port coupler. Using the syringe, air from the hose and the (still closed) service port was pumped to the top of the syringe. At this point, the liquid level in the syringe (or hose) was made note of.

The LCS was positioned so that the service port was the highest point in the system. The service port valve was opened. Then the syringe plunger was pushed slowly and released, several times. Air bubbles emerged from the LCS and found their way to the syringe. When no more air would come out, the pump was run for a few seconds. The the syringe was used to pump air out again. This was continued until the pump sound was even. Several orientations of the LCS were tested with the pump running.

When the pump sound was even in several different orientations, the service valve was closed. Before closing the valve, the liquid level in the syringe was checked too see that it was lower than before. Bleeding took around 5 to 10 minutes in total.
