Subject: SSD7101A—macOS Boot Camp Test Report

1. Test Environment

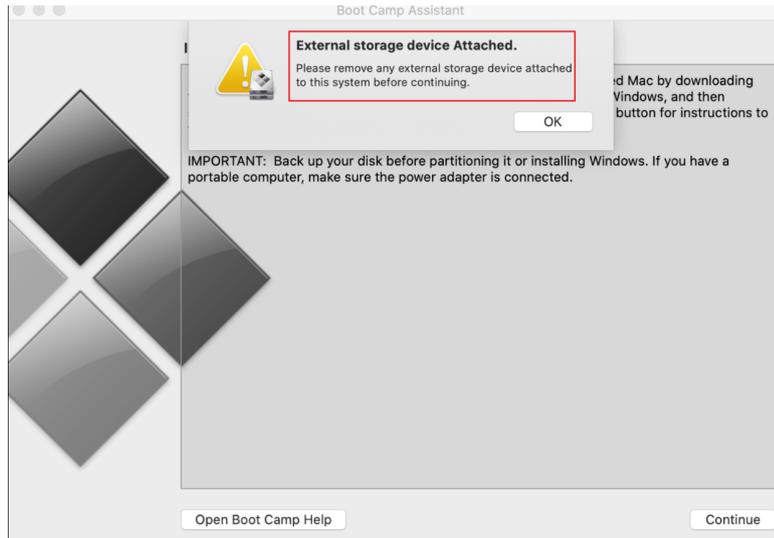
- 1) The Windows system directly installed with External Drive cannot be used on Mac Pro 2019;
- 2) Both SSD7101A and OWC ACCELSIOR 4M2 do not support Boot Camp to install

Windows;

- 1) Both SSD7101A and OWC OWC ACCELSIOR 4M2 do not support Boot Camp to install Windows;
- 2) Need to use Boot Camp to install the Windows system on the Mac. Currently cannot install the Windows system directly to the disk;
- 3) Boot Camp requires Internal Drive to install Windows system;
- 4) Mac Pro 2019 can only use the built-in Macintosh HD for Windows (Boot Camp) partition

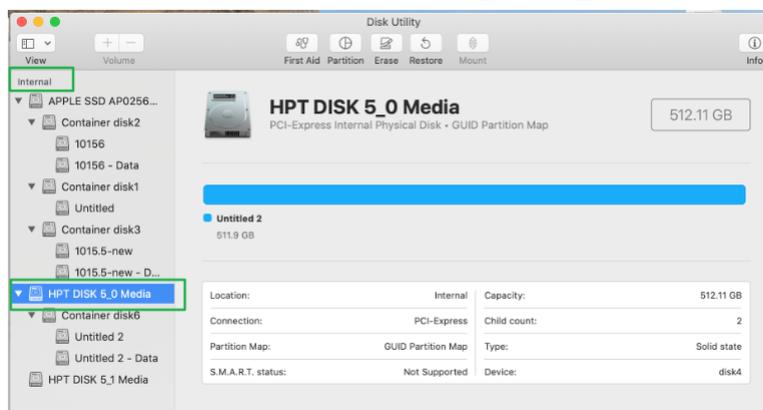
- 3) Use HighPointNVMe.internal driver to change HPT Drive to External Storage Device

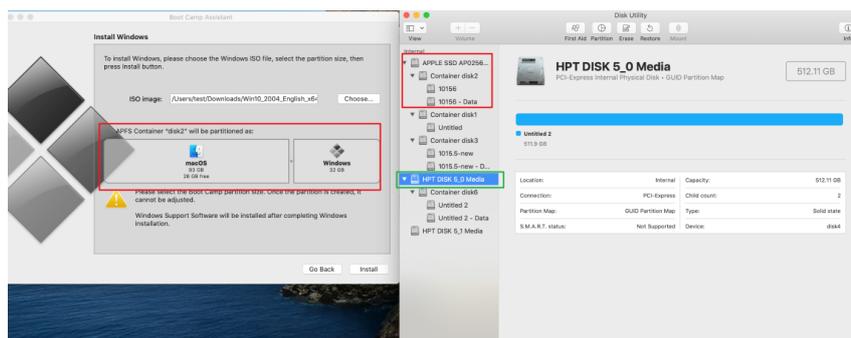
- 4) After HPT Drive is changed to External Storage Device, Boot Camp still automatically selects the Macintosh HD partition to create the Windows partition, and it cannot be changed manually
